Influence of Solution Treatment on Cold Drawing of CuNi₂Si Rods

Abstract. The influence of different microstructures resulting from the solution heat treatment of previously pressed rods of the CuNi₂Si alloy on the process of cold drawing is reported. The best workability was obtained with rods having a uniform microstructure and without precipitates. On the other side, a non-uniform microstructure with the coarse grain boundary Ni₂Si precipitated particles results in a periodical appearance of arrow-like macrocracks. This material not suitable for cold drawing was a straight consequence of an inadequate solution treatment. By accommodating solution treatment parameters, all these defects were successfully eliminated and satisfactory quality of rods was obtained.

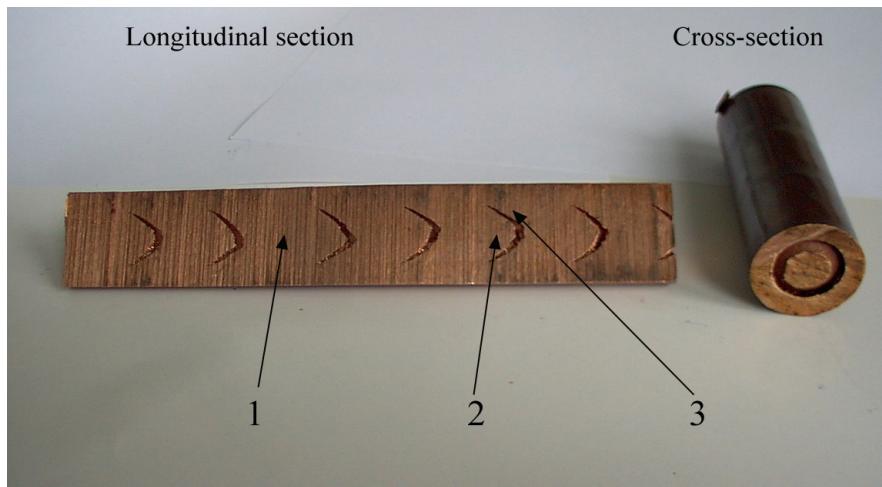
However, during drawing some quenched rods vibrated and some waves could be seen on their surface. The cross-cut section of these rods (defined as VBR rods in further text) clearly revealed the appearance of hidden defects. Characteristic ring-shaped defects have been found: a relatively thick part near the surface was separated by a ring-shaped hollow from the central part of the rod. On the other side, longitudinal section revealed a periodical appearance of macrocracks in the form of an arrow point. All these defects are shown in Fig. 1.

Fig. 1. Longitudinal and cross-section of the rod.

Due to a relatively great number of rods (mass of rods vs. capacity of the furnace was inadequate) subjected to solution treatment at 800°C, the time necessary to transform the microstructure into the uniform α -solid solution was short, resulting in a non-uniform microstructure after quenching. Actually, the temperature of the outer parts of rods reached 800°C, the temperature that will bring Ni₂Si into α -solid solution. Central parts of rods, however, were heated at temperature lower than 800°C and Ni₂Si remained at grain boundaries as nondissolved globular and plate-like particles. In the following process of cold drawing these rods were observed to vibrate since the outer part of rods could be easily deformed passing through die, whereas the central parts were brittle due to grain boundary Ni₂Si particles. Interfaces between ductile Cu matrix and brittle Ni₂Si particles were regions for initiations of microcracks. The overall result is that these rods in longitudinal direction show hidden defects in the form of periodical appearance of arrow point-like macrocracks. To eliminate this problem, the smaller number of rods was inserted into the furnace and annealed at 800°C for the same time as in the previous case. After quenching the microstructure was uniform (similar to microstructure in Fig. 4) and no difficulties were experienced during drawing in the further practice.

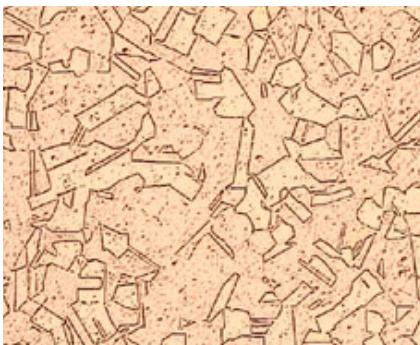
Fig. 2. Pressed and air-cooled rod. (100x)

The microstructure is uniform throughout the cross-section. Coarser Ni₂Si particles are precipitated at grain boundaries, whereas smaller particles may be seen inside the grains.

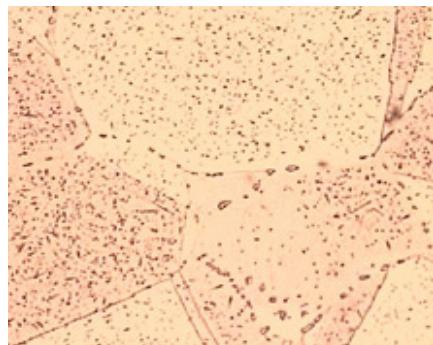
Fig. 3. Pressed and air-cooled rod. (1000x)

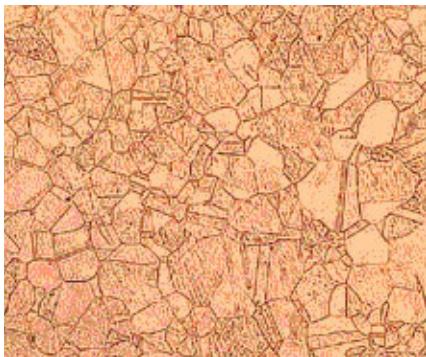
II quenched rod. Figs. 4 and 5 show microstructure of the rods water-quenched after solution treatment at 800°C. The structure is uniform throughout the cross-section. There are no precipitated Ni₂Si particles at the grain boundaries. Rods with this structure were drawn without any problems.

Fig. 4. Water-quenched rod. (100x)

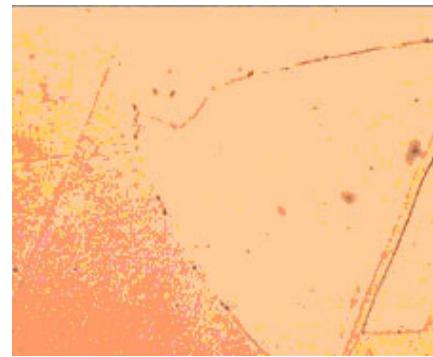
Fig. 5. Water-quenched rod (1000x)

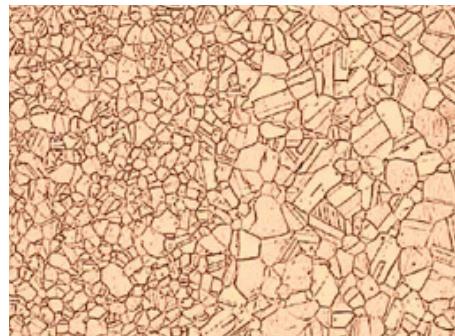
Fig. 6. Microstructure of the water-quenched rod, the cross-section; the segment between the edge and the center of the cross-section. (100x)

Microstructure of the cross-section is not uniform. Grains towards the center of the rod are small and round in shape with Ni₂Si particles precipitated at the grain boundaries, whereas the region near the surface of the rod consists of larger polygonal grains without precipitates.

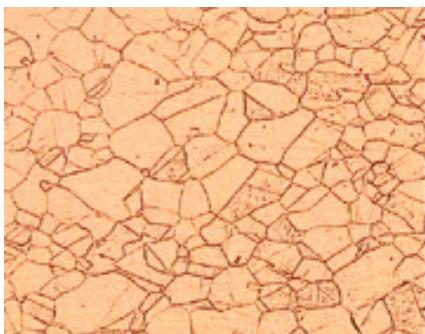
IV Drawn VBR rod – specimens with hidden defects. Specimens were taken from three locations of the longitudinal section – denoted as positions 1, 2 and 3 in Fig. 1. Microstructure of position 1 corresponds to the area between two arrow-like macrocracks (Fig. 7.). Under higher magnification (1000x) globular particles may be seen at grain boundaries (Fig. 8.). Coarse globular and plate-like Ni₂Si particles precipitated at grain boundaries are characteristic for positions 2 and 3 in Fig. 1 (Figs. 9 and 10). Even at low magnification (100x) microcracks formed at grain boundaries may be clearly seen in the vicinity of position 2 and 3 (Figs. 11 and 12). Higher magnification illustrates that microcracks are originated in the area where coarse or plate-like particles were precipitated (Figs. 13 and 14).

Fig. 7. Microstructure of position 1 (in Fig. 1). (100x)

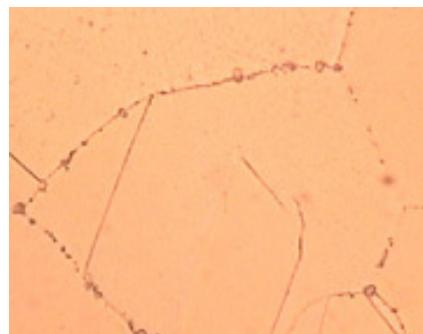
Fig. 8. Microstructure of position 1 (in Fig. 1). (1000x)

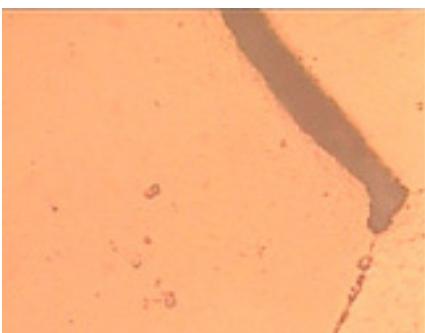
Fig. 9. Microstructure of position 2 (in Fig. 1). (100x)

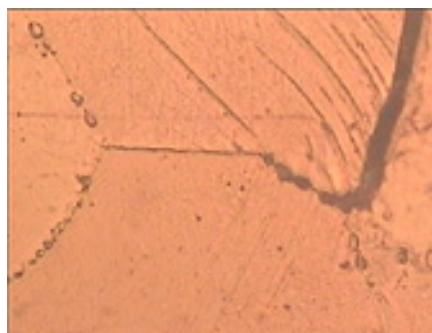
Fig. 10. Microstructure of position 3 (in Fig. 1). (100x)

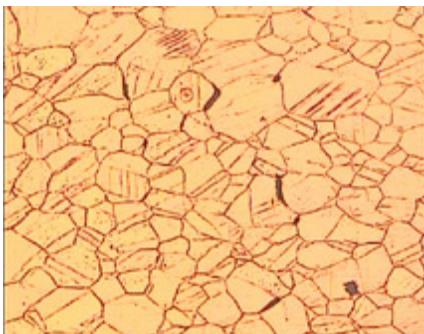
Fig. 11. Microstructure of position 2 (in Fig. 1).
(100x)

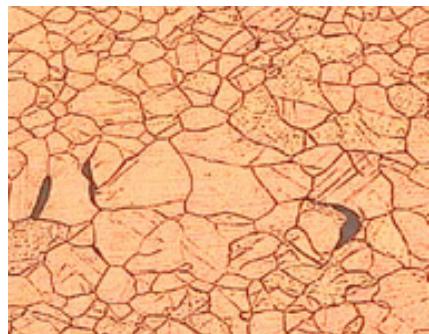
Fig. 12. Microstructure of position 3 (in Fig. 1).
(500x)

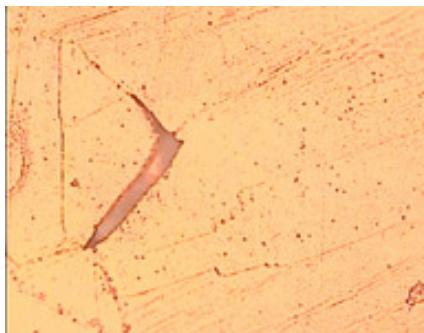
Fig. 13. Microstructure of position 3 (in Fig. 1).
(500x)

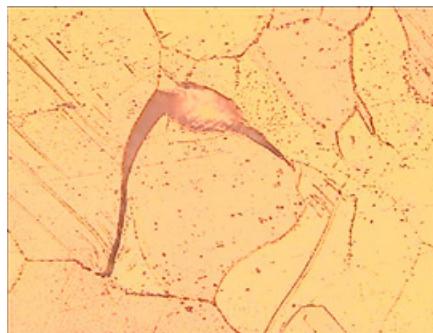
Fig. 14. Microstructure of position 3 (in Fig. 1).
(500x)
