TEM and Dual Beam (SEM/FIB) investigations of subsurface cracks and White Etching Area (WEA) formed in a deep groove ball bearing caused by Rolling Contact Fatigue (RCF)

Aleksandro Grabulov^{1,2,a} and Henny W. Zandbergen²

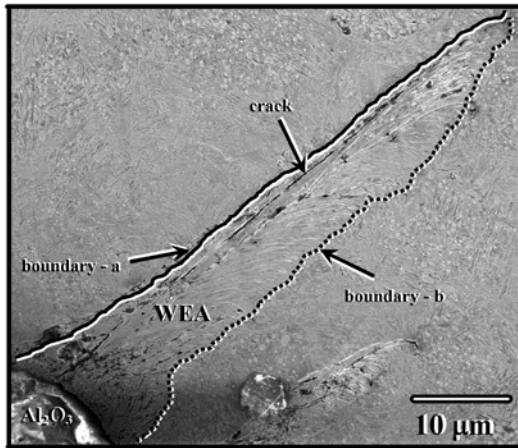
Fig. 1. SEM image of a butterfly crack formed around Al_2O_3 inclusion indicates the White Eatching Area (WEA) “butterfly wing” having two boundaries: one containing a crack, notated as “boundary-a”, and the other without a crack notated as “boundary-b”. (Longitudinal section with over-rolling from left to right)

SEM Investigations. Figure 1 shows a SEM image of investigated butterfly wing. We observed that all butterfly wings are oriented in the direction of over-rolling and lie at an angle of approximately 45° with respect to the raceway (rolling surface). This fact was previously observed by several researchers, suggesting that the main reason for the orientation of the wings is shear stress that has its maximum value in this direction [5,6]. The cracks extend from the Al₂O₃ particle to the tip of the butterfly wing and form a sharp boundary between the steel matrix and the WEA (Figure 1). The other side of the wing has a feathery, non-smooth boundary in agreement with literature [4]. The origin of the crack is at the contact surface between matrix and the inclusion. Figure 4a shows this interface, being the origin of the cracks. The area marked as “1” represents the place where part of Al₂O₃ was present and removed during the sample preparation process. The area “2” contains large number of microcavities present in the region. The decohesion of inclusion and surrounding matrix causes the nucleation of voids that can lead to the formation of cavities as those visible in Figure 4a [7]. It is likely that under continued straining those cavities grow and coalesce into a central crack which propagates away from the inclusion into the material along localized shear planes at 45° respect to the raceway [8]. This interpretation is strongly supported by previously mentioned observation that butterfly crack lies at the angle of 45° in respect to the over-rolling direction. It is generally accepted that the detrimental effects of the inclusion on the

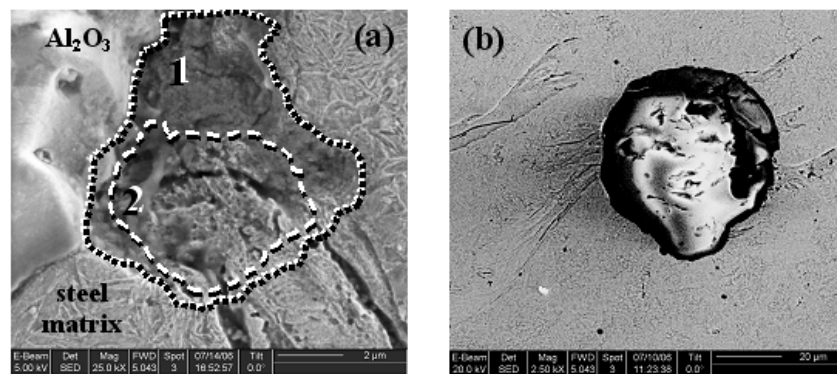
mechanical properties of the steel are caused by the stress-rising effect or by a weak bonding force at the interface between the inclusion and the surrounding matrix [3]. The residual stress and the stress rising around the inclusion in the combination with the shape of the interface between inclusion and the matrix can result in the formation of multiple cracks and butterfly wings as shown in Figure 4b.

Fig. 4. (a) SEM image of the interface between inclusion and steel matrix. The areas marked as “1” and “2” represent the position where part of Al₂O₃ was located (removed during sample preparation). The area marked as “2”, and from which the crack has initiated, shows a large number of microcavities. (b) SEM image illustrating the multi butterflies formation from an alumina inclusion.

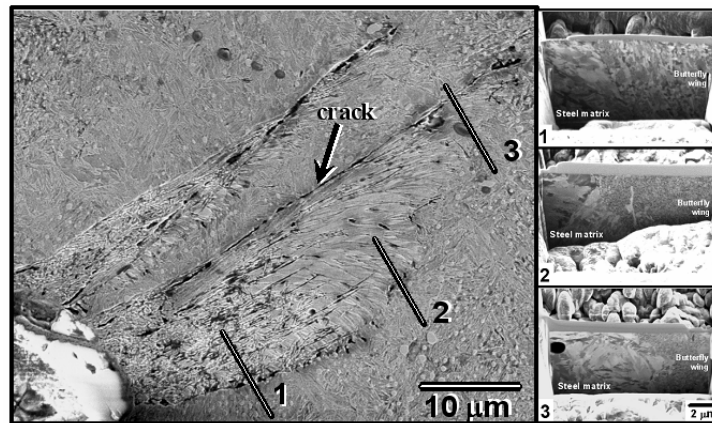
TEM Investigations. In order to determine the microstructural differences within the WEA, TEM investigations were carried out. Figure 5 shows one butterfly wing and the locations of TEM samples produced by FIB. This figure also presents the cross section FIB images of TEM lamellas just before their removal. Those images show a clear difference in the microstructure between the steel matrix and White Etching Area. The microstructure also varies within the butterfly wing (WEA) as shown in the cross sections of the lamellas at the locations indicated as 1, 2 and 3 in Figure 5. The size of the grains within WEA gradually decreased in the direction from aluminum oxide towards the tip of the crack (lamella 3 has the smallest grains).

Fig. 5. SEM micrograph showing the butterfly wing and the TEM sample locations. Microstructural difference between the butterfly wing and the steel matrix are clearly visible in the cross sections made by FIB.

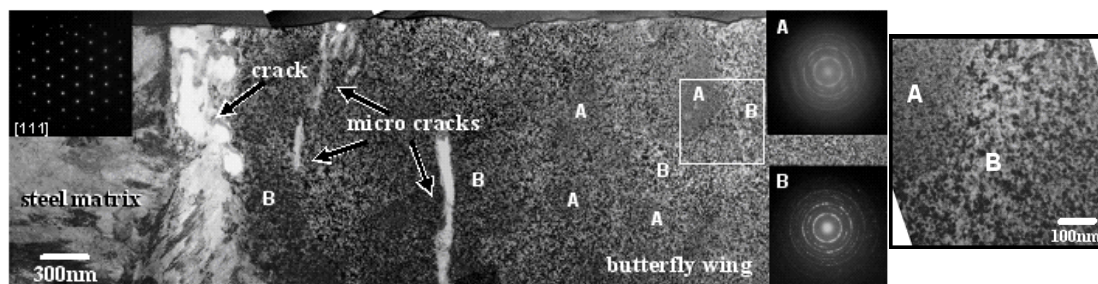
Figure 6a and 6b show TEM images (lamellas 2 and 3 respectively) of the butterfly wing containing the crack and surrounding steel matrix. Large microstructural differences are clearly visible; the steel matrix shows a microstructure of tempered martensite, while the region of butterfly wing (WEA), shows only very fine ferrite grains and no temper carbides. The boundary between those two zones is sharp, indicating that large microstructural changes occurred within WEA. Previous reports [9,12,13] suggested formations of voids in the WEA, and other early observations [4,10,14] reported existence of ferrite grains within WEA. We observed that the main crack was located in the boundary between WEA and the steel matrix and surrounded with secondary micro cracks and voids. We conclude that the formation of secondary micro cracks and voids are the result of high stresses and microstructural changes during RCF (Figure 6a). Further investigations in this study proved that the ultra fine nano-crystalline ferrite grains indeed exist within WEA. Selected Area Diffraction Patterns (SADP) taken from both steel matrix and butterfly wing are shown in Figure 6a. The SADP from steel matrix shows BCC [111] zone axis, while the patterns taken from WEA show rings in diffraction pattern fitting BCC structure of ultra fine nano-crystalline ferrite grains. The ultra-fine ferrite grains vary in size within the WEA. Figure 6a shows few different areas marked as “A” and “B” inside the butterfly wing (WEA). The existence of amorphous-like

regions consisting of very fine ferrite grains are found in areas “A” and larger ferrite grains are distributed along the cracks and between amorphous-like regions (regions “B”). The SADP from both locations (“A” and “B”), clearly indicates difference in the grain size (Figure 6a). Close inspection of the boundary between steel matrix and the WEA, showed the microcracks formed inside the steel matrix, between the martensitic plates, which is in agreement with the previous reports [15] that is a result of the high stresses and deformation present close to the main crack.

Fig. 6. TEM cross section micrograph of the butterfly wing showing microstructural difference between the WEA and the steel matrix.(a,b represent lamellas 2 and 3 respectively) a) SADP identified the formation of ultra fine nano-crystalline ferrite grain within WEA (“A”: amorphous-like regions, “B”: larger nano-crystalline grains).

We concluded that the observed very fine (nano-sized) ferrite grain structure in the butterfly wings is a result of a recrystallisation process, where new grains form from the highly deformed steel matrix adjacent to the crack faces. This plastic deformation induces high dislocation density, but also high concentrations of crystal point defects. Recrystallisation requires sufficiently high iron self-diffusivity, which normally means thermal activation of vacancy formation and vacancy migration. This translates into the need for a markedly increased operating temperature. In bearing operation, such temperatures can neither be identified as a high steady-state temperature nor as temperature spikes during exposure to the contact stress field. The observed low-temperature recrystallisation effect is here instead interpreted [16] such that the crystal point defects generated during the plastic deformation resulting from the RCF exposure are stabilized by presence of carbon in solid solution [17]. This eliminates the need to thermally activate the formation of vacancies, but only to invoke their mobility to support the recrystallisation process. This is anticipated to readily occur under typical bearing operating conditions.

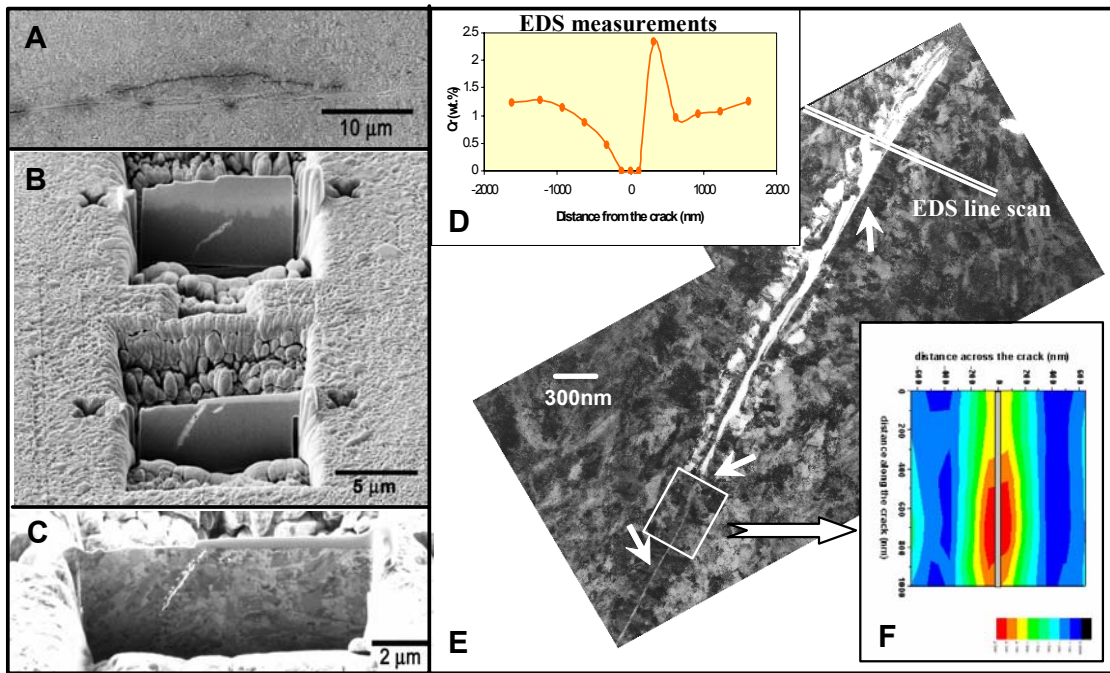
Subsurface microcracks found in the inner ring of the bearing were investigated using TEM and FIB. The SEM observations of the inner ring cross section (Figure 7a), revealed the formation of subsurface cracks. It was found that the cracks were always parallel to the rolling surface. The size

of the cracks vary from few microns up to 20-30 μm , and they are located in depth range of 300-500 μm from the rolling surface. The SEM investigations show no evidence of non-metallic inclusion or any defects to be cause of the crack initiation. This could be an indication that these cracks were formed only due to the rolling process and stresses applied during RCF. In order to investigate the microstructure close to the cracks, in-depth observations were performed using series of cross sections made by FIB, which were further investigated by TEM (Figure 7). It was observed that all cracks are oriented approximately 45° with respect to the raceway, as shown in Figure 7b. This proved that the cracks were formed in the direction of the maximal shear stress as previously explained in this paper.

Fig. 7. *A)* SEM image of the subsurface crack, *B)* TEM samples prepared by FIB (lamellas containing the crack), *C)* Lamella prior to final cut, *E)* TEM image of the crack shown in “C”, *D)* Diagram presenting EDS measurements (positions marked in “E”) of Cr content, *F)* Cr wt% content measured by EDS in area marked in “E”.

TEM image of one subsurface crack is presented in Figure 7e. The microstructure of this crack is very different from the cracks observed close to non-metallic inclusions (e.g. butterflies). This suggests that the mechanism of the subsurface crack formation is different from the cracks formed close to non-metallic inclusions. TEM analyses show that the bottom part of the crack is ~ 30nm wide and it gradually opens up to ~ 250nm at the top. In the image one can observe a ~ 50nm wide bands with a darker appearance (indicated in Figure 7e with the arrows). EDS investigations showed a higher concentration of chromium in the bands. Line scans along the cracks from the top of the bottom showed that Cr reaches 2.30 wt.% in average. Figure 7d, represents such a line scan, showing that there is decrease of Cr content on one side of the crack. It was observed that at the other side of the crack Cr content increase rapidly (the layer observed in TEM image) followed by decrease to the minimal value (600nm away from the crack). On the other side of the crack, Cr content is gradually increasing reaching the initial Cr content (~ 1,5 wt%). Figure 7f shows the distribution of Cr from the section of the bottom part of the crack in. The highest concentration of Cr is found in a region close to the crack, decrease further away form the crack and finally stabilizing at the initial Cr content.
