Structure Changes Due to Service Deformation and Oscillations in Low Pressure Turbine Blades

Keywords: Turbine blades, structural changes, coagulation of pores, cracks

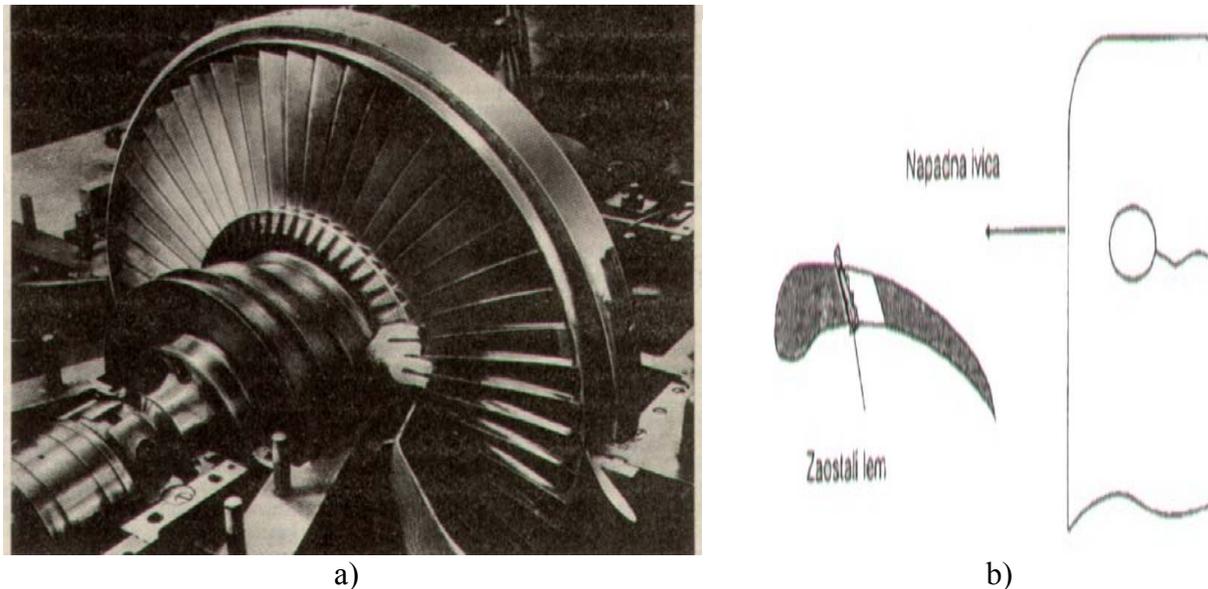
Working conditions in low pressure turbine. Blades of different dimensions (lengths and mass) are arranged on turbine rotor in 38 rows, as it's shown in Fig. 1a). The working temperature inside the turbine is in the range of $100\div 40^\circ\text{C}$: the highest incoming temperature does not overcome 100°C , while the outgoing temperature is at least 40°C .

Fig. 1. View of turbine rotor with blades in maintenance repair a) and cross-section of a blade b)

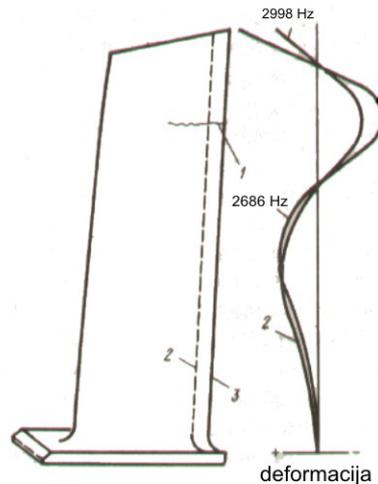
The lines of vibrations are easily visible by using the method of holographic interferometry [10]. Greater oscillations and deformations of blade are positioned at lower frequency, see careful Fig. 2. It represents an acceptable explanation for the reason of crack appearing, see pos.1. in Fig. 2.

Fig. 2. Deformations along the blade for two values of oscillations
1-crack; 2-new edge of blade; 3- edge of blade

From the aspect of blade vibrations, the crack will be expected only at some positions, as it was illustrated in Fig. 2, This kind of crack usually is initiated at the blade surface. In another case, when an aggregation process of pores occurs, the coagulation and coarsening of pores may provoke the crack initiation not on the surface, but in the bulk of the blade material (Fig. 6b).

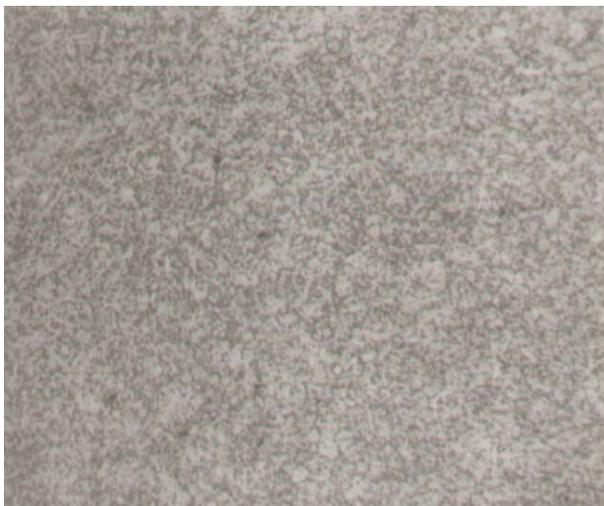
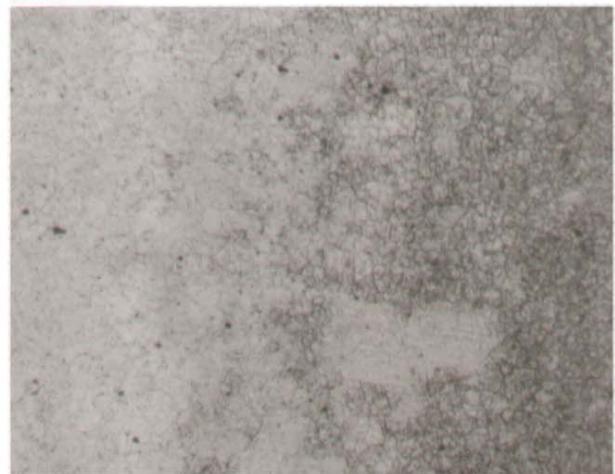
A mixture of ferrite and chromium carbides (Cr_7C_3 type) with retained austenite [1-6] is present in the microstructure of the blade after 40.000 hours in service. According to microhardness values (in the range of 240-270 $HV_{0,1}$) which are approximately the same along the cross section it is concluded that this structure is obtained by the normalizing annealing. This kind of structure is shown in Fig. 3a). However, the edge of the thinner part of blade is quenched and tempered with hardness $\approx 440 \mu HV_{0,1}$, see Fig. 3b). Such a choice of heat treatment could be explained by the need for increasing strength and resistance to high level of vibrations on the blade edge.

Fig. 3. Microstructure of turbine blade: a) fully homogenous structure and
b) quenched and tempered condition; x 185,

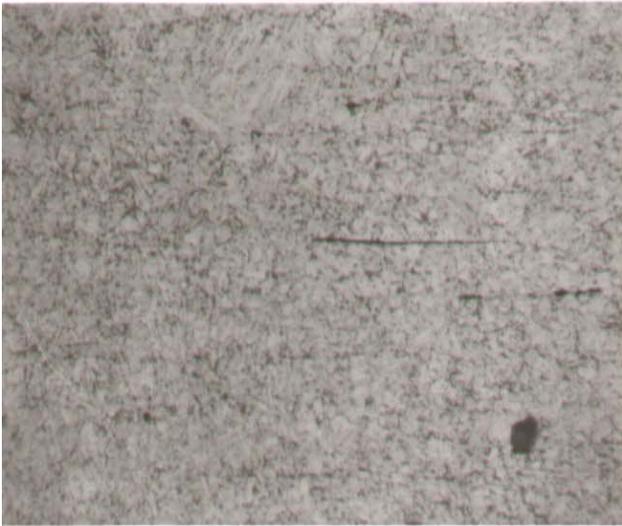
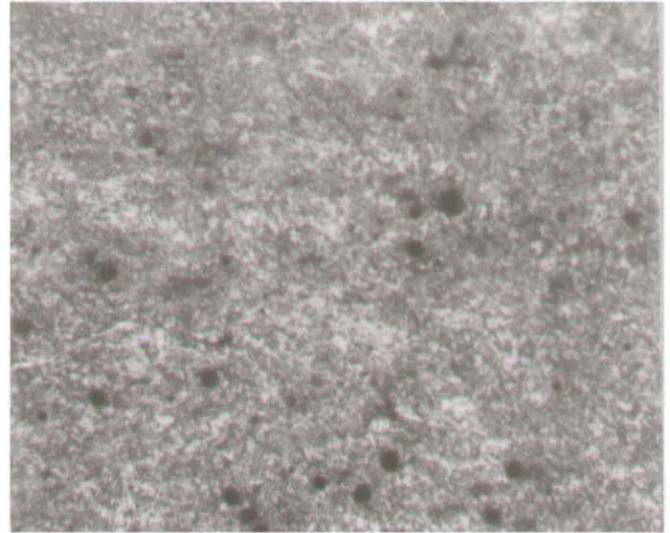
In addition, in the cross section of blade non-metallic inclusions are found, see Fig. 4a). These inclusions are visible both in longitudinal and cross-section of blade (Figs. 4a and b, respectively).

Fig. 4. Non-metallic inclusions in a) longitudinal direction and b) cross section of blade, x 185

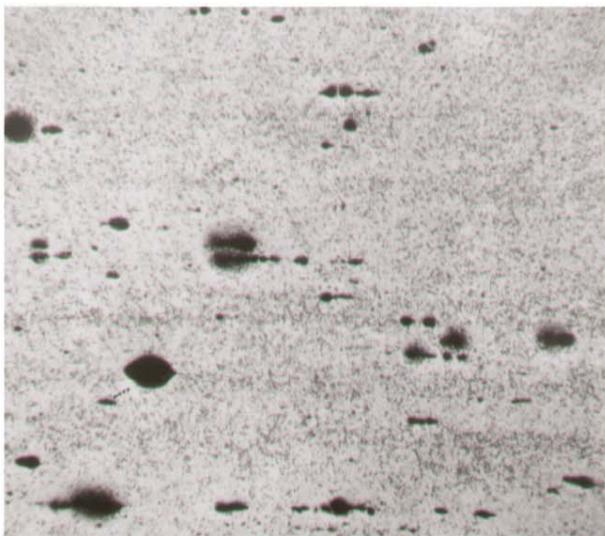
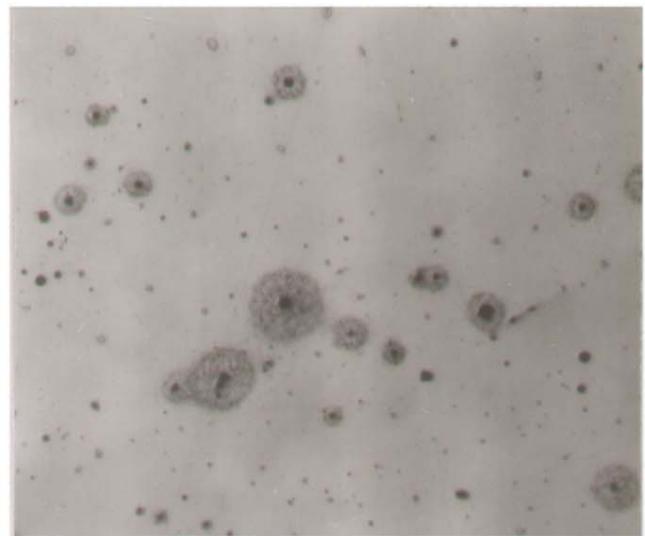
Serious problems may arise due to these non-metallic inclusions since they are surrounded by a number of individual pores (fig. 5a) or even characteristic “clouds” of pores are formed around inclusions (fig. 5b).

Fig. 5. Non-metallic inclusions associated with pores in: a) longitudinal and b) cross sectional direction of the blade, x 185

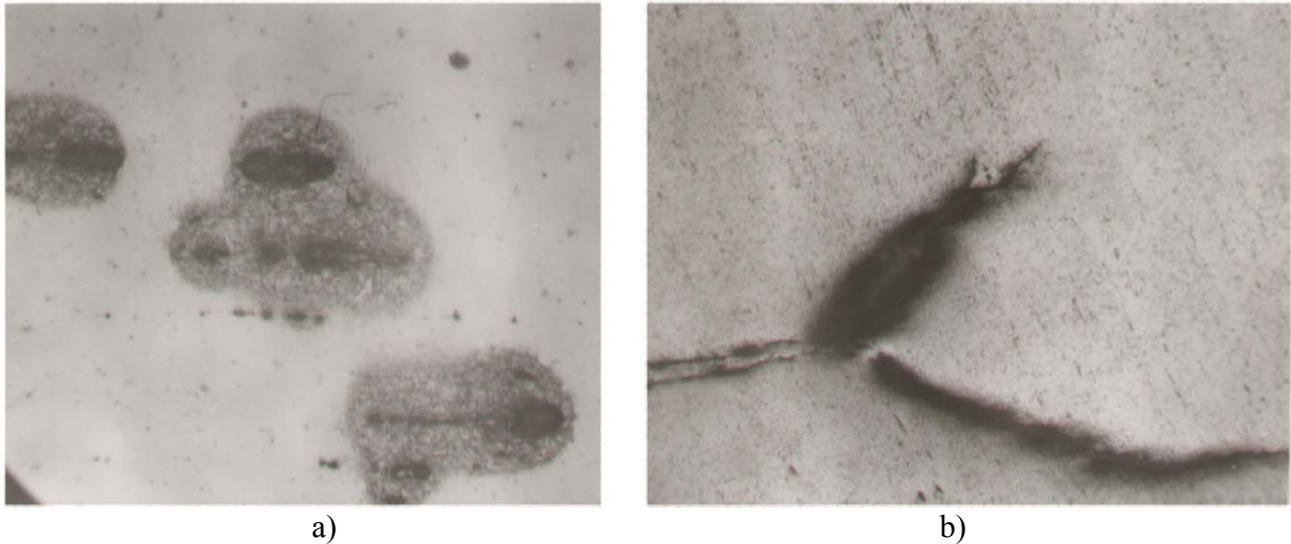
The significant changes in the microstructure may arise when “clouds” are aggregated in clusters around non-metallic inclusions (Fig. 6a). As a consequence of such aggregation and probable coagulation of pores, the cracks will be easily formed, as it is shown in Fig. 6b).

Fig. 6. Aggregated non-metallic inclusions a) and cracks in blade b) x 185

It should be mentioned that those coagulated pores could not be identified by using other testing techniques (ultrasound or similar) but only by using a metallographic analysis.
